BALANCE OF PRODUCED WASTE IN LAGOONS OF THE FORMER OIL REFINERY IN KUÇOVA TOWN, ALBANIA

LALAJ Nensi, PRIFTI Irakli

Abstract. The District of Kucova, is a part of a higher administrative unit, Berat. The premises of the former refinery are located on a total area of about 25 ha. Currently, this site is without any industrial use; from the geomorphological point of view, the wider vicinity of the site can be characterized as a flat region with local elevations not exceeding 25 m. The former refinery lies in the floodplain of the Driza valley. The highest point of the premises is located on a Neogene elevation, which runs through the western part of the premises and reaches an altitude of about 53 m. The lowest-lying part of the premises reaches an altitude of about 36 m. The oil refineries in Kucova had a great impact on the environment. Currently, they do not work and are sold for scrap. However, the environment is still polluted by petroleum products remained from the former refinery. In this paper, we will discuss only about the former oil refinery in Kuçova town. The article is the result of research work carried out by different institutions. The results refer to the year 2011

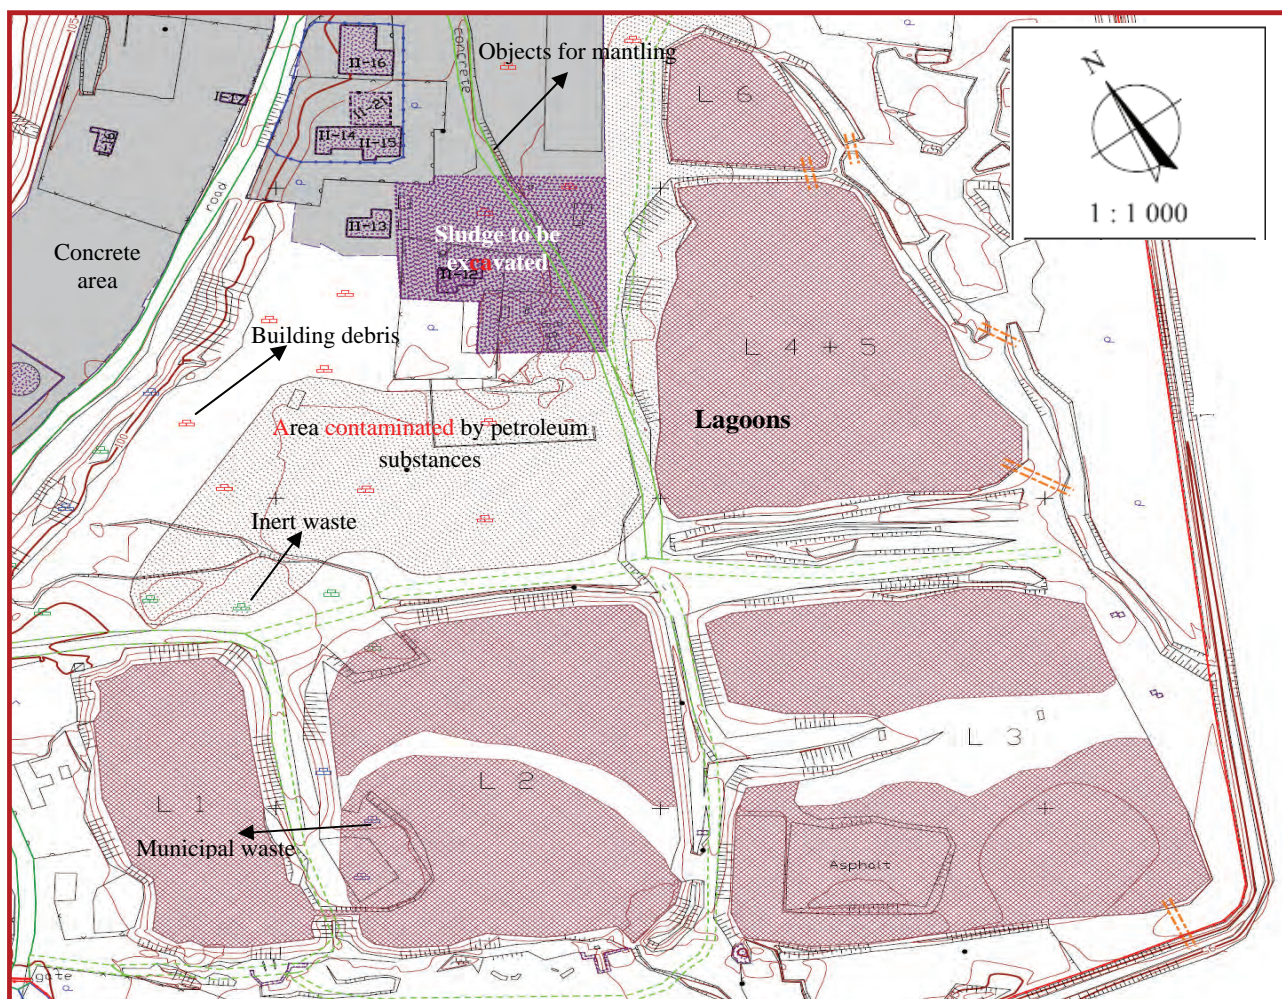
The topographic survey is conducted by licensed companies. The results of the topographic survey are presented in the archive of the Municipality of Kucova. On the basis of this report there is estimated the surface of lagoons. In this area, there are not included the dykes between the lagoons (Fig. 1).

Figure 1. Topographic map of the lagoons and east are of former petroleum refinery (original).

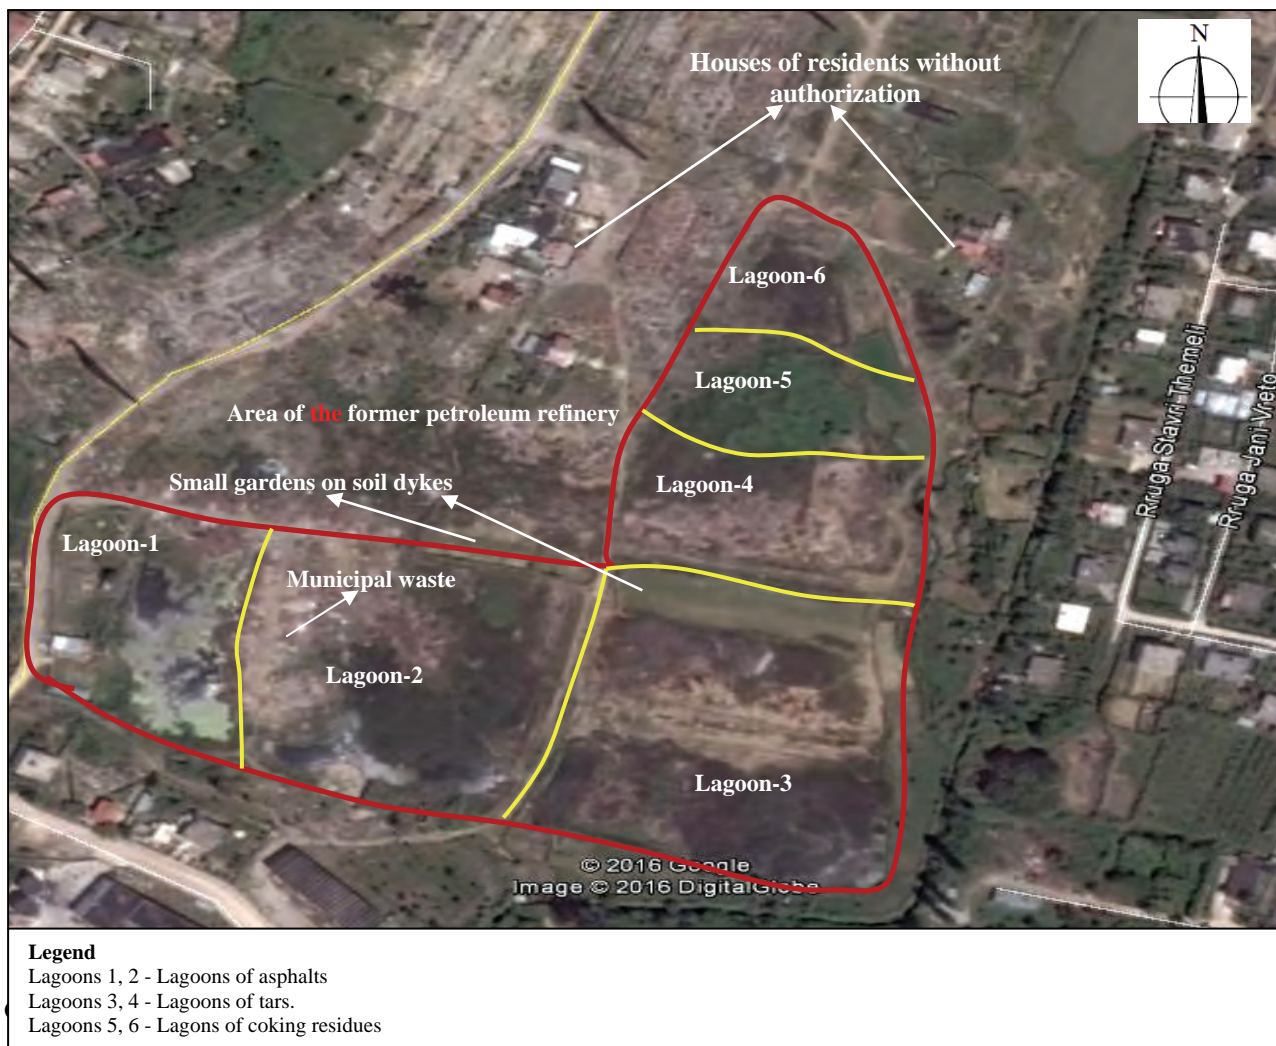
In case of lagoon no. 1, the presence of ps (petroleum substances) contamination was sensorially and analytically verified at a depth interval of 0.2 – 2.7 m of underlying soils in the area adjacent to the foot of the Neogene elevation. It is not certain whether the contamination is connected with wastes deposited above the soils or whether it is rather transport contamination originated from another area. In a part of the lagoon no. 1, which lies closer to the axis of the valley, the presence of contamination of underlying rocks was not detected (Fig. 2).

Figure 2. Topographic map of the Lagoons 1 - 6 (original).

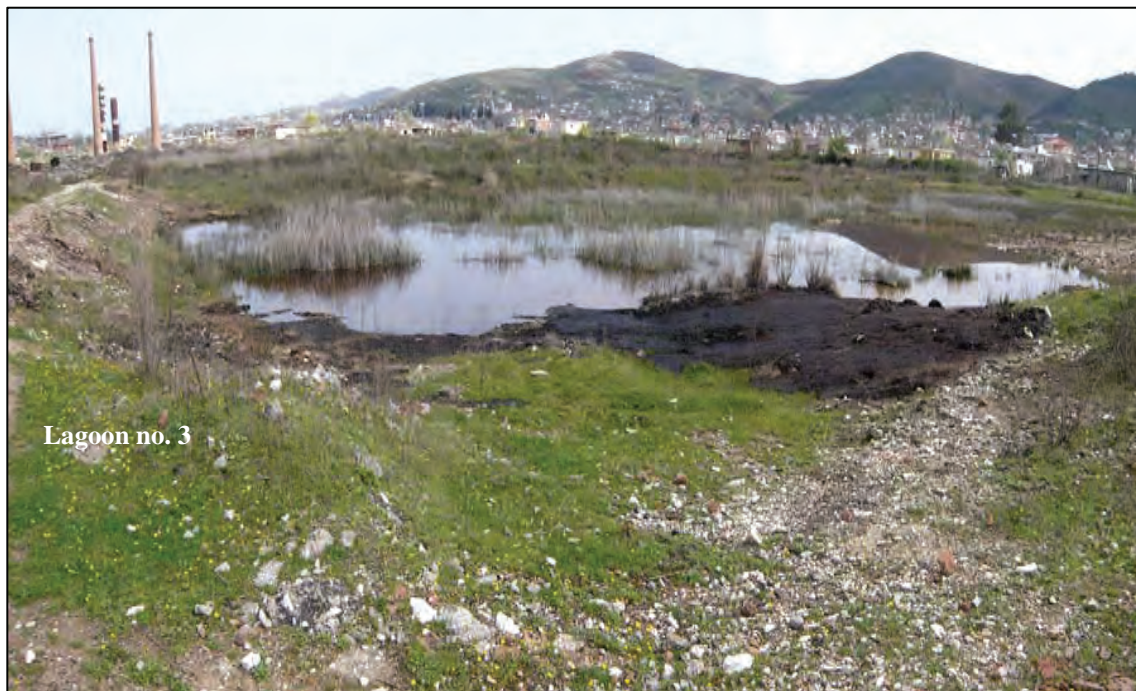
Photo 2. Lagoon no. 3 (original).

Balance of waste of the lagoons no. 3 and 4. Tars (acid substances) were deposited in these lagoons in the past. The survey verified their presence in both the lagoons and they have a maximum thickness of 0.8 m. The following table shows a general calculation of the balance of tars deposited in these lagoons.

The presence of contamination, besides wastes, was detected by sensorial evaluation in all dug holes, practically in its entire thickness, which ranges from about 1.5 m. to 3.5 m. and is predominantly represented by clays to sandy clays. The total area of contaminated soils underlying the wastes can be estimated on the basis of the known surface area of the lagoons at about 12,000 m², including dykes (Table 2).

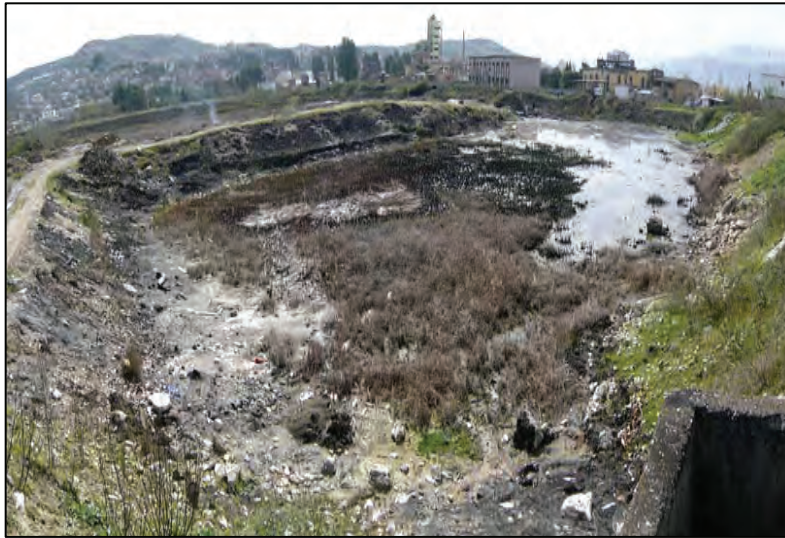
Photo 3. Lagoon no. 2 (original).

Beneath the lagoon no. 2, we mention the presence of a contaminated layer of sandy clays sometimes of about 0.5 m in thickness. Theoretically, a very limited amount of potential contaminated leachates from wastes can penetrate this layer and reach the underlying layer of water-saturated highly sandy clays (Table 1).

Some diggings located in the southern dyke of the lagoon no. 2 verified the presence of a contaminated layer of slightly sandy clays at a depth interval of about 1.0 – 2.0 or 2.0 – 3.0 m, respectively. A layer of fills with waste was detected in other digging at a depth interval of about 1 to 2 m. Contamination of slightly sandy clays can originate from overlying layers containing waste, from where it can spread farther down to the underlying layer of water-saturated highly sandy clays. It may also be caused by the accumulation of contaminants in the zone of groundwater fluctuation; groundwater transports contaminants from other parts of the former oil refinery.

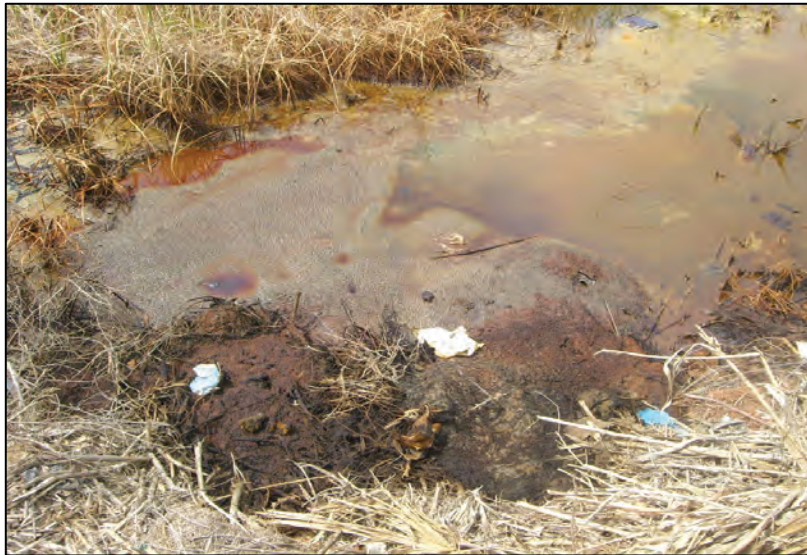
Photo 4. High level of toxicity on lagoon no. 2 (urban waste) (original).

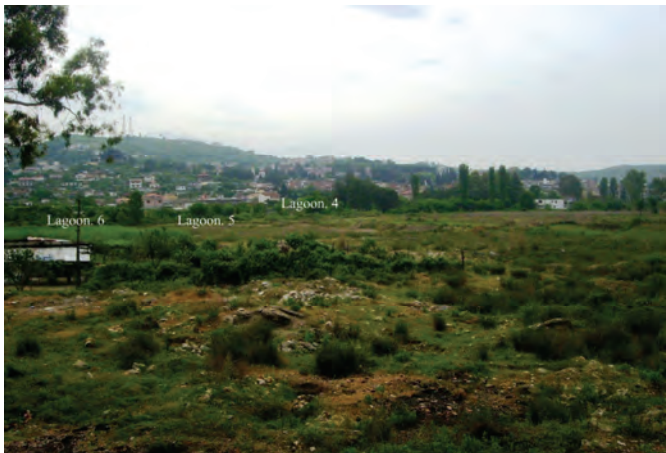
Photo 5. Lagoons no. 4, 5, 6 (original).

Balance of waste of the lagoons no. 5 and 6. Wastes from the coking operation were deposited in these lagoons in the past. When the survey was conducted, the ground in this hot spot was so inaccessible that the planned survey work could not be carried out. Based on consultations with the representatives of the former management of the refinery, the maximum thickness of the deposited waste could be about 0.5 – 1.0 m. The surveyed surface area of the lagoon no. 5 is of about 2,900 m² and of the lagoon no. 6 of about 1,200 m², altogether about 4,100 m². Due to the absence of data from the field survey and details on the character of operation, no balance was prepared for this type of waste. An estimate of the volume of waste deposited in the lagoons nos. 5 and 6 is 2,050 to 4,100 m³.
