GEOLOGICAL VULNERABILITY OF THE A1 HIGHWAY. CASE STUDY ON THE ACILIU SECTOR (SIBIU COUNTY)

STELEA Ion, GHENCIU Monica

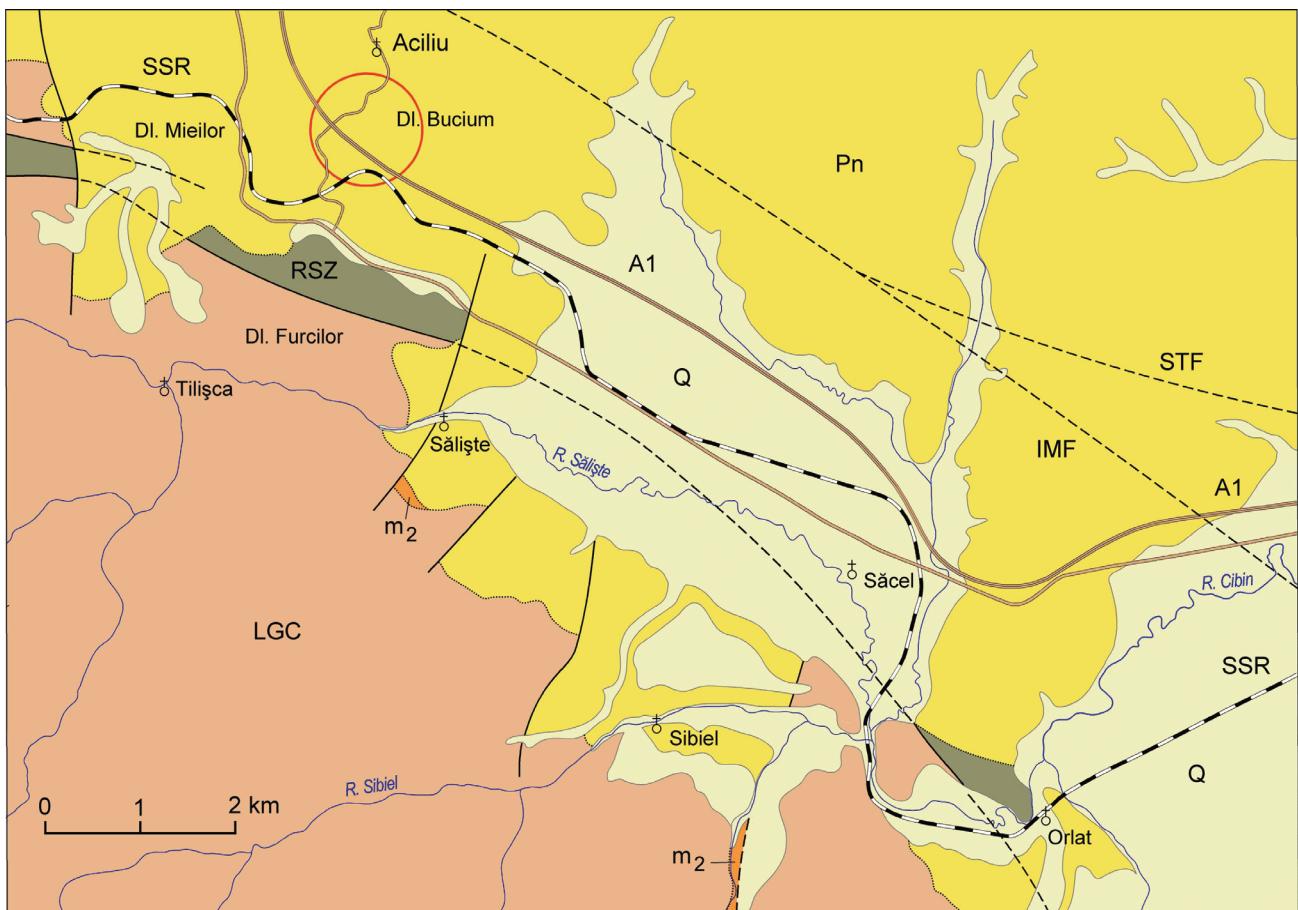
Figure 1. Simplified geological map in the Aciliu area (after STELEA & SĂNDULESCU, 1993). Legend: Q-Quaternary deposits; Pn-Panonian formations; m₂- Badenian formations; LGC-Lower Getic Complex; RSZ-Răşinari Shear Zone; IMF-Intramoesian Fault; STF- South Transylvanian Fault; A1-A1 highway; SSR-Sibiu-Sebeș railway; Red circle- Location of the photos in Figs. 2 and 3. Details in text.

Metamorphic formations. The metamorphic basement of the Cibin Mountains in this region mainly consists of gneissic rocks representing the lower complex of the Getic Crystalline (Fig. 1). This includes two metamorphic formations, one of micaceous gneisses with lenses of amphibolites and pegmatites, at the top, and one of augen gneisses with remnants of undeformed coarse-grained granitoids, at the bottom. Micaschists and quartzo-feldspathic gneisses from the upper complex appear only on small areas. A diverse range of fine-grained mylonitic schists, mainly chlorite and feldspathic schists, with interlayered marbles and amphibolites outcrop along a major tectonic lineament corresponding to the Răşinari Shear Zone.

At the topographic surface, the Pannonian formations develop on large areas in this region (Fig. 1), while Badenian and Sarmatian formations outcrop on small areas, only on the basement margin (STELEA & SĂNDULESCU, 1993). The Badenian is represented by dacitic tuffs and tuffites with rare intercalations of marls, sometimes marls and clays. The Sarmatian is represented by calcareous sandstones, sands and gravels with intercalations of marls. The Pannonian deposits consist of thick sequences of sands and clayey sands with thin lenses of gravels, and marls with thin intercalations of unconsolidated sandstones.

Four major tectonic lineaments join on the south-western border of the Transylvanian Depression, without taking into consideration the presumed Oltului Fault, insufficiently documented. These are the Intramoesian Fault, on NW-SE direction, the South Transylvanian Fault, on E-W direction, the Răsinari Shear Zone, on the NW-SE direction in this region, and the Sadu Fault, on the WSW-ENE direction. The first three faults cross the Aciliu area, their trace being buried under the Pannonian sedimentary deposits (Fig. 1). Only the Intramoesian Fault is active, but the frequent

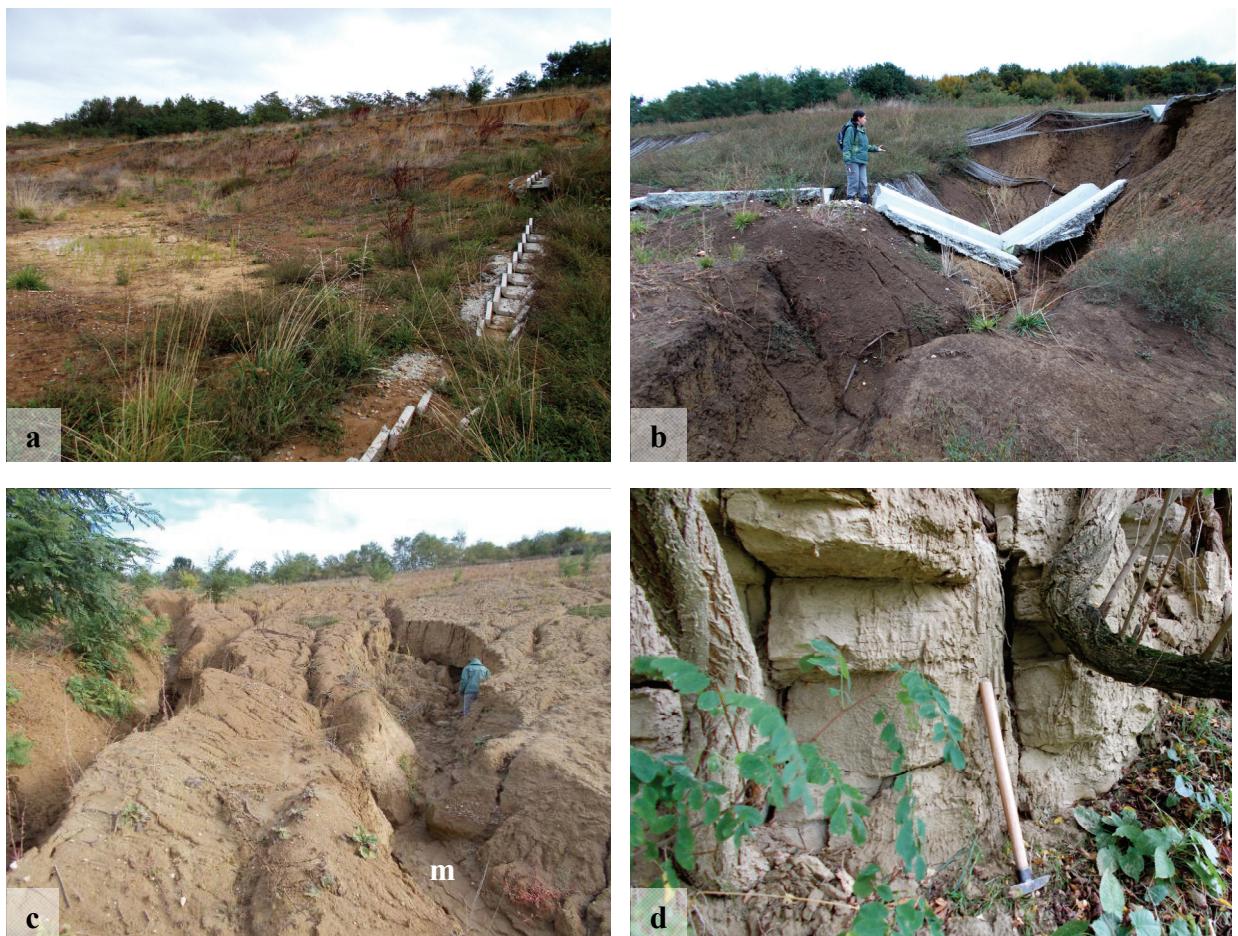
A succession of marls and sands with decimetric levels of fine gravels outcrops on the northern side of the Bucium Hill. On its southern side, reddish clays outcrop in the eastern part of the highway cutting slope, severely affected by landslides with gullied scarps of 1-4 meters high (Figs. 2a, b). Yellow-reddish clayey sands with decimetric levels of sands and gravels outcrop in the western part of the cutting slope, affected by a branched system of 2-3 meters deep gullies exposing the marls beneath (Fig. 2c). The same marls outcrop on the western side of the hill, under the Aciliu Viaduct (Fig. 2d). Yellow-reddish clayey sands also outcrop on the opposite cutting slope, affected by parallel gullies following the line of greatest slope.

Figure 2. Outcrop photographs in the Bucium Hill area (original, September 2017). a, b) Landslides in the clays from the eastern part of the cutting slope; destroyed drainage works and textile net are seen. c) Gullies in the clayey sands from the western part of the cutting slope, with marls (m) on the bottom of the deep gullies. d) Systematically fissures on NW-SE direction in the Pannonian marls under the Aciliu Viaduct (detail).

Details in the Aciliu area. In the outcrops of marls on the western side of the Bucium Hill, under the Aciliu Viaduct, have been measured a set of equally spaced fissures, NW-SE oriented (Fig. 2c), and a set of joints NNE-SSW oriented. Joints with NW-SE and NNE-SSW orientations also occur in the marls on the northern side of the hill. In the marls levels that occur in the sands on the eastern side of the Mieilor Hill, on the other side of the A1 highway, have been measured NW-SE and N-S oriented joints, with calcite efflorescences.

In September 2017, all the drainage works made in the Aciliu cutting slope on the Bucium Hill (drainage channels, pipes and collecting channels), as well as the textile net for soil protection, were practically destroyed by still active landslides and gullies (Figs. 2a, b; 3a). Water is gathering and a hydrophilic vegetation grow behind the sliding mass (Fig. 2a). The landscape is desolated. We mention that there were no landslides on the southern side of the hill prior to the cutting excavation.

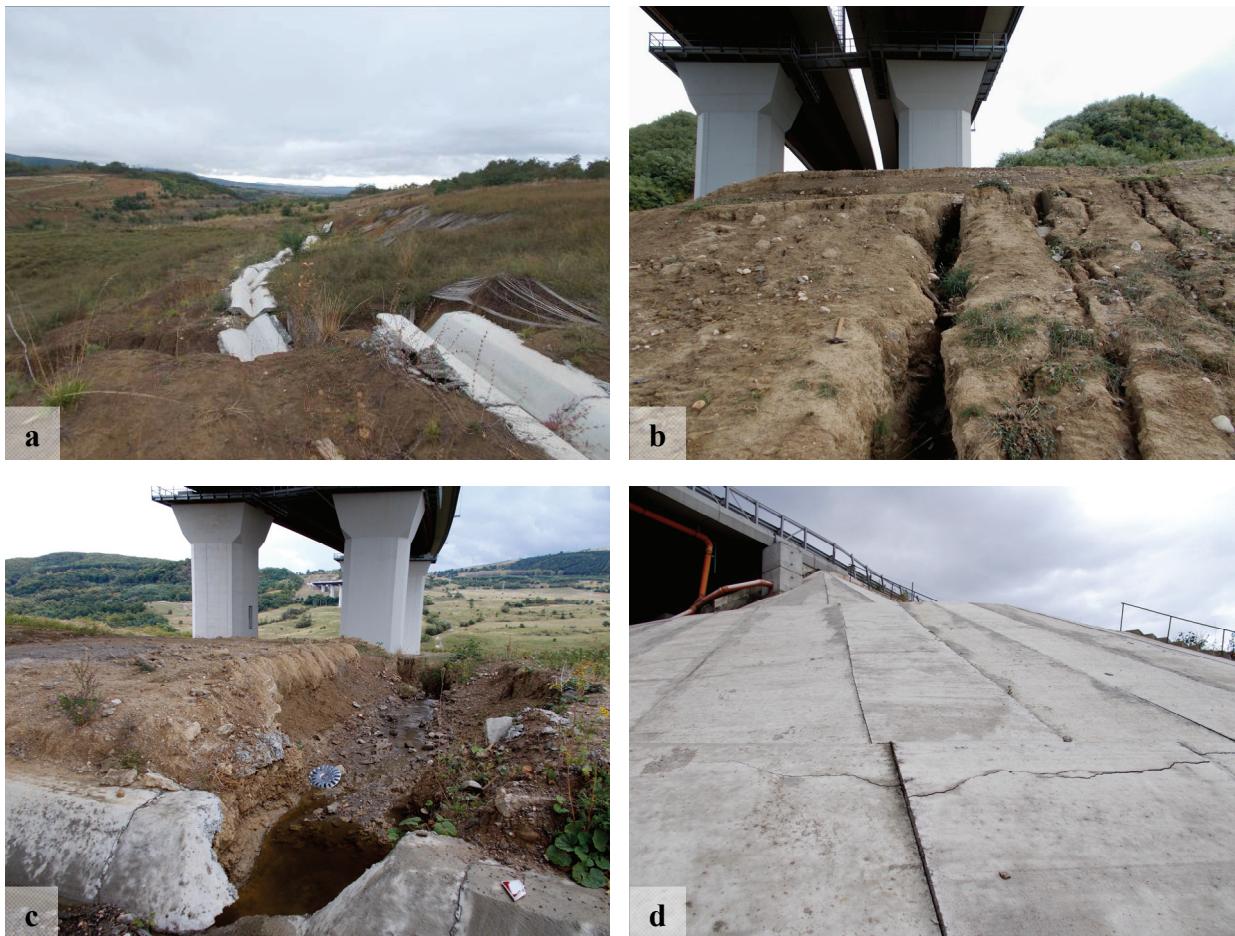
Gullies of 1-4 meters deep appeared at the heads of the Aciliu viaduct, between the abutments and the downstream pilots (Figs. 3b, c), especially at the north-western head, toward Apoldu de Jos, where the works at the abutment were affected; the drainage channels were broken and the concrete slabs for the embankment protection were cracked and dislocated (Figs. 3c, d). The two abutments have already fallen once, the north-western one in 2015, and

the south-eastern one, toward Săliște, in 2016. Although these have been repaired, the problems appeared again. Considering the geological structure of the ground and the vibrations caused by the road traffic, correlated with the effects of atmospheric precipitation, we anticipate that these damages will increase in the future.

Figure 3. Photographs of the highway construction works (original, September 2017). a) Broken collecting channel on the cutting slope (Bucium Hill). b) Gullies at the pilots down the eastern head of the Aciliu Viaduct. c) Broken collecting chanel and the subsequent gully at the western head of the Aciliu Viaduct. e) Cracked and dislocated concrete slabs at the western head abutment.

The Pannonian formations outcrop at 450 meters elevation under the Aciliu Viaduct, and at 315 meters elevation in the banks of the Secaș River near Apoldu de Jos. Therefore, the thickness of the sands, clayey sands and marls deposits in this sector of the A1 highway is of 100-130 meters. This means that the viaduct pilots, buried 40 meters deep, are fixed in the Pannonian soft rocks noway in hard rocks, term geologically equivalent with magmatic and metamorphic rocks. Evidence is the stability problems which appeared and continue to appear at the viaduct heads.

The technical solution for crossing through cutting the Bucium Hill did not consider the geological structure of the ground. Cannot stop with textile nets the sliding of a high hill of 613 meters excavated down to the highway elevation which is 550 meters in this sector. Above the highway there are over 50 meters of sedimentary formations with alternation of permeable and waterproof lithologies, systematically fissured on NW-SE direction, parallel to the highway in the Aciliu sector, but intersecting the highway in the Apoldu de Jos sector. The hill will continue to slide until it reaches the natural slope of the rocks from which it is constituted and the drainage works will be permanently destroyed. It is possible that the railway above the opposite cutting slope to be also affected.
